U.S DEPARTMENT OF THE INTERIOR
NATIONAL PARK SERVICE
HUBBELL TRADING POST NATIONAL HISTORIC SITE, ARIZONA
MAINTENANCE, OPERATION, AND SAFETY OF DAMS PROGRAM

2001 Joint National Park Service and Bureau of Reclamation
Literature Search and Review and Site Visit Report

Hubbell Reservoir

Prepared By
Technical Service Center
Bureau of Reclamation
Denver, Colorado
January 2003

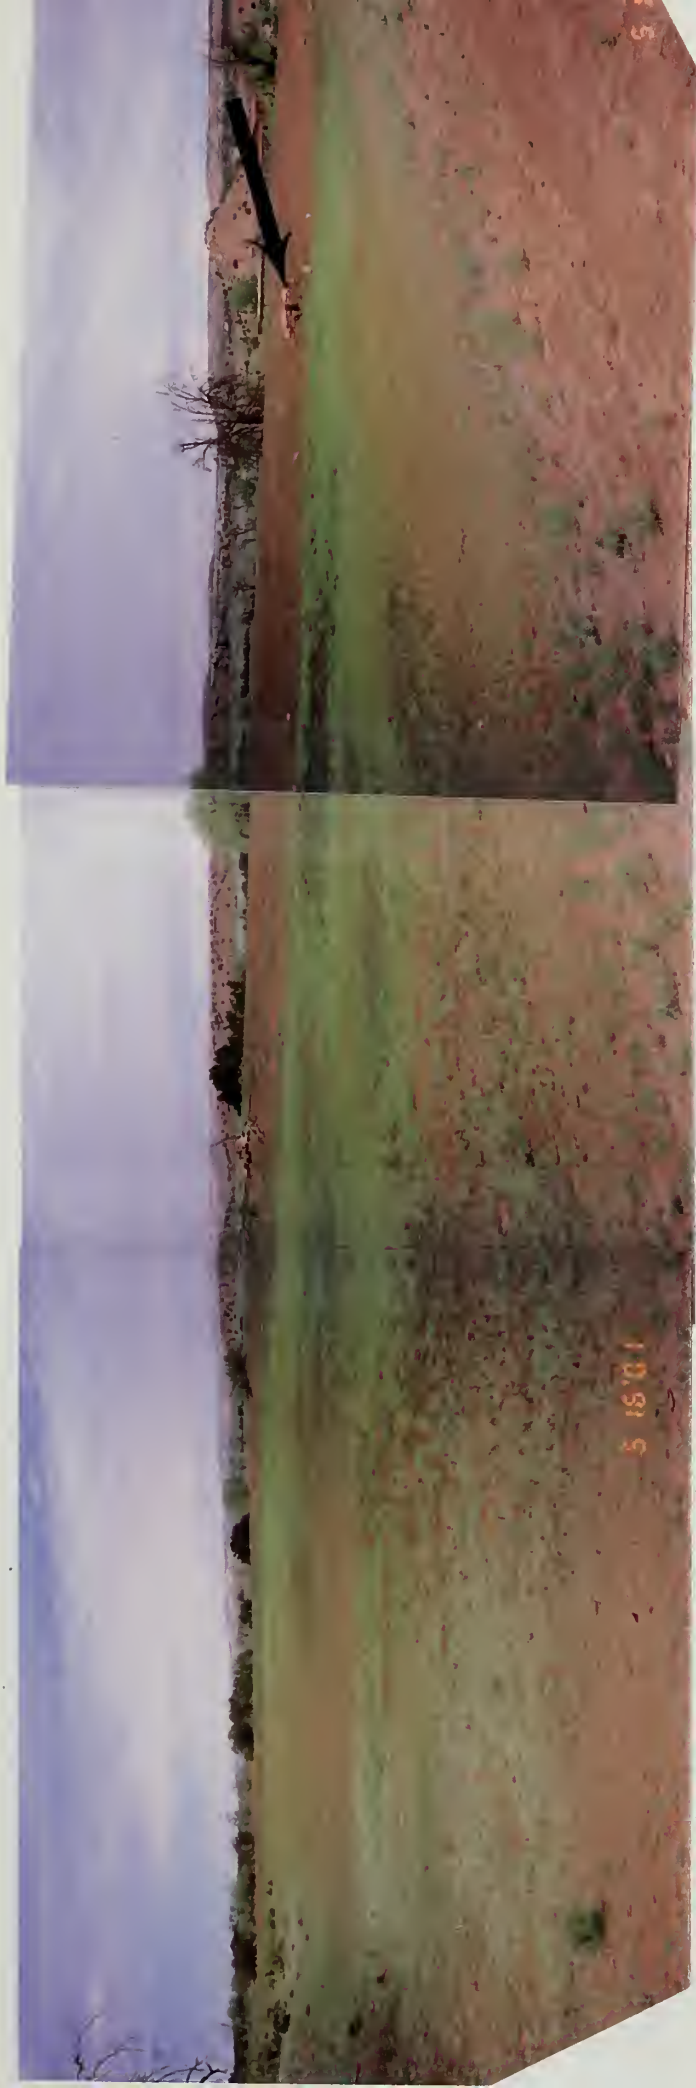
There is no cracking, settlement, or other sign of structural distress on the dam. No major erosion was observed on the embankments, even though slope protection is absent except for sparse vegetation on the embankment faces (photos 1 and 2). Although no serious deficiencies were visible during this examination, it should be recognized that the exterior appearance does not indicate whether the embankments were constructed with properly designed filter and transition zones and toe drains, or whether proper compaction methods were employed during construction. Trees and brush growing on and near the embankments (photos 3 and 4) are not desirable, but removal is not considered necessary because the reservoir does not currently store water, and removal would require breaching and reconstructing the embankment at locations of deep-rooted vegetation. The trunks and limbs from trees that were previously cut down on or near the north embankment segment are lying on the embankment crest as shown in photograph 3; removal is not necessary. Isolated animal burrows were observed on the north embankment segment (photo 5), but activity by burrowing animals did not appear to be widespread [LS-No Apparent Inspection and Maintenance Program].

Photo 1. Hubbell Reservoir - Reservoir area viewed from the right upstream corner of the reservoir. The arrow indicates the low-level outlet at the right end of the downstream embankment. 5/16/01

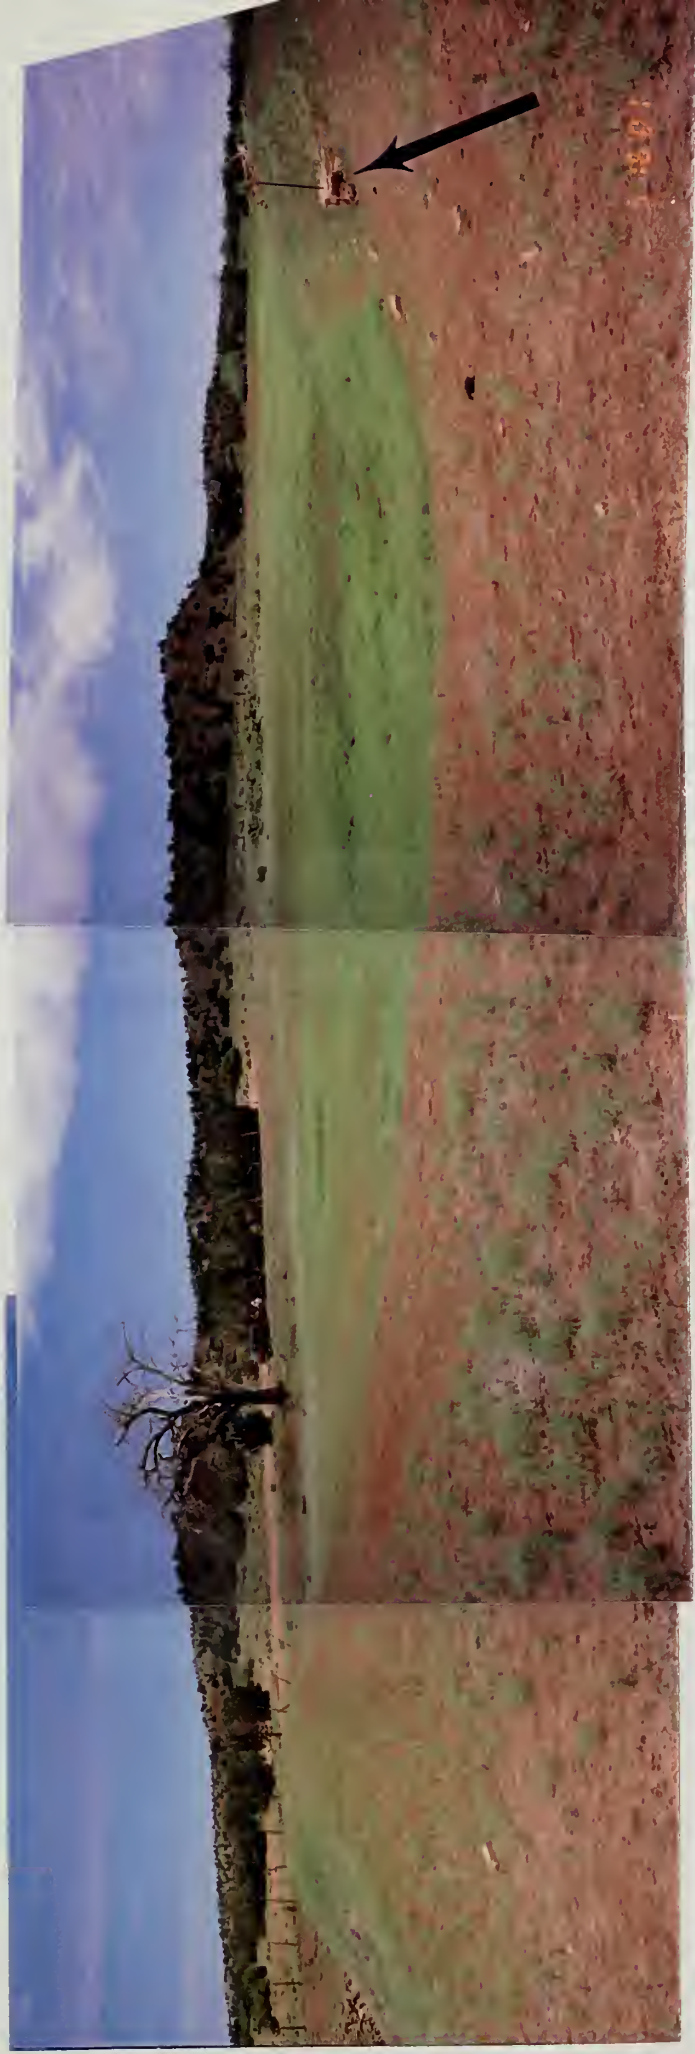
Photo 2. Hubbell Reservoir - Reservoir area viewed from the right end of the downstream embankment. The arrow indicates the low-level outlet.

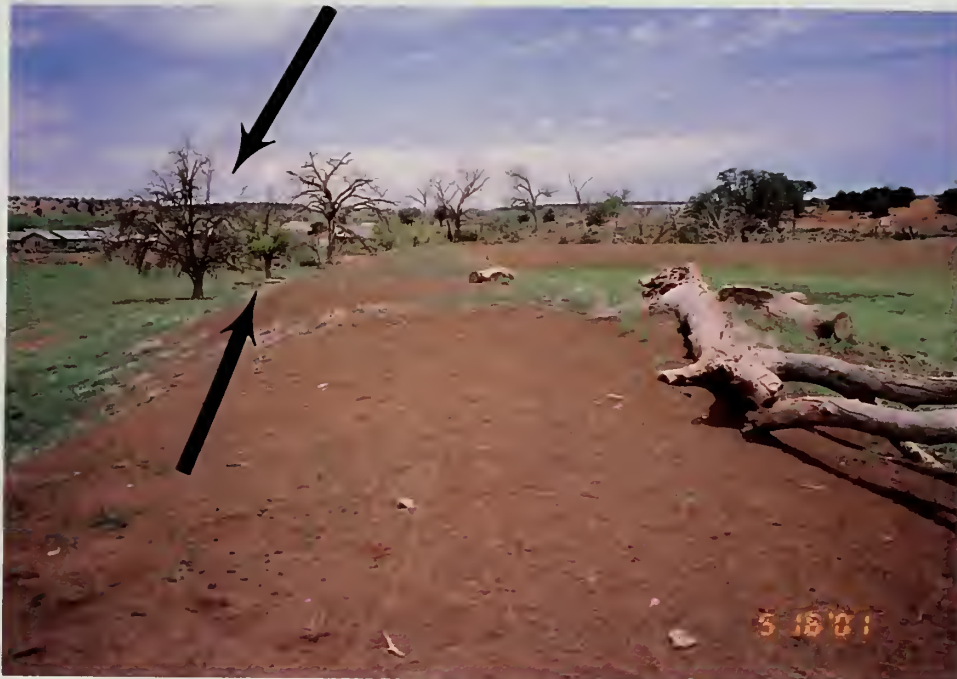
Photo 3. Hubbell Reservoir - Main (north) embankment, looking to the right (east). The upper arrow indicates a large tree growing on the downstream toe; the lower arrow indicates the masonry training walls that are the remnants of the low-level outlet terminal structure. 5/16/01

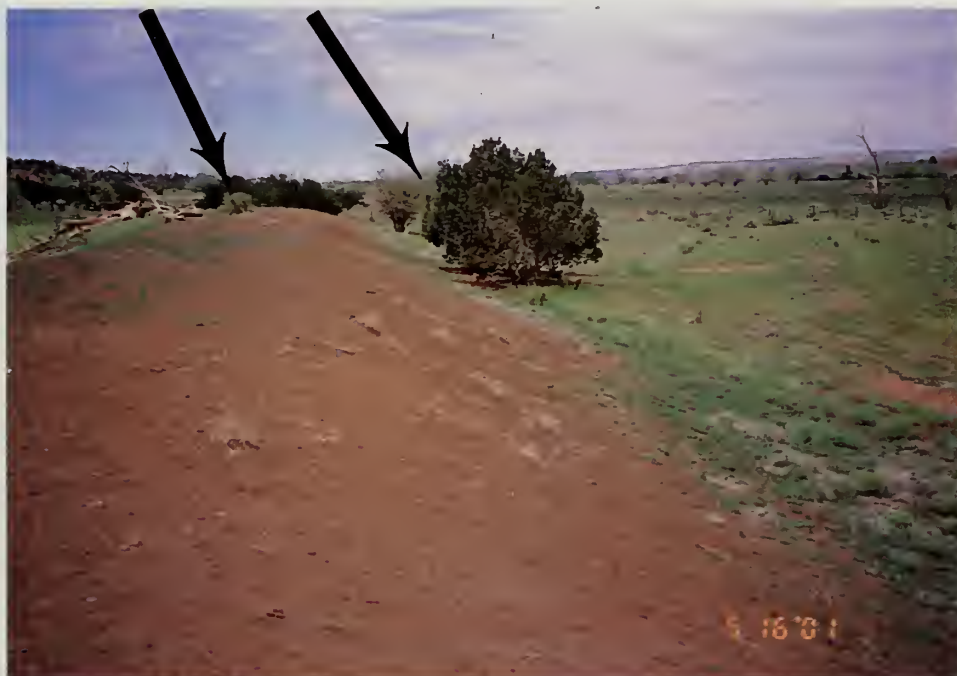
Photo 4. Hubbell Reservoir - Main embankment looking left. The arrows indicates trees and brush growing on the embankment crest and downstream toe. 5/16/01

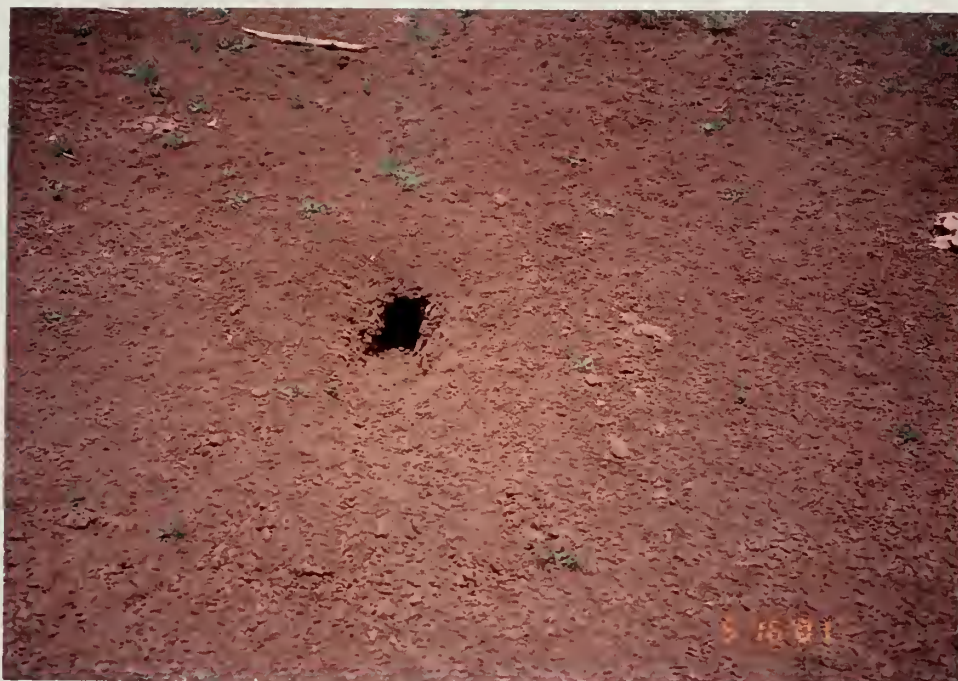
Photo 5. Hubbell Reservoir - Animal burrow on the upstream edge of the main embankment segment.

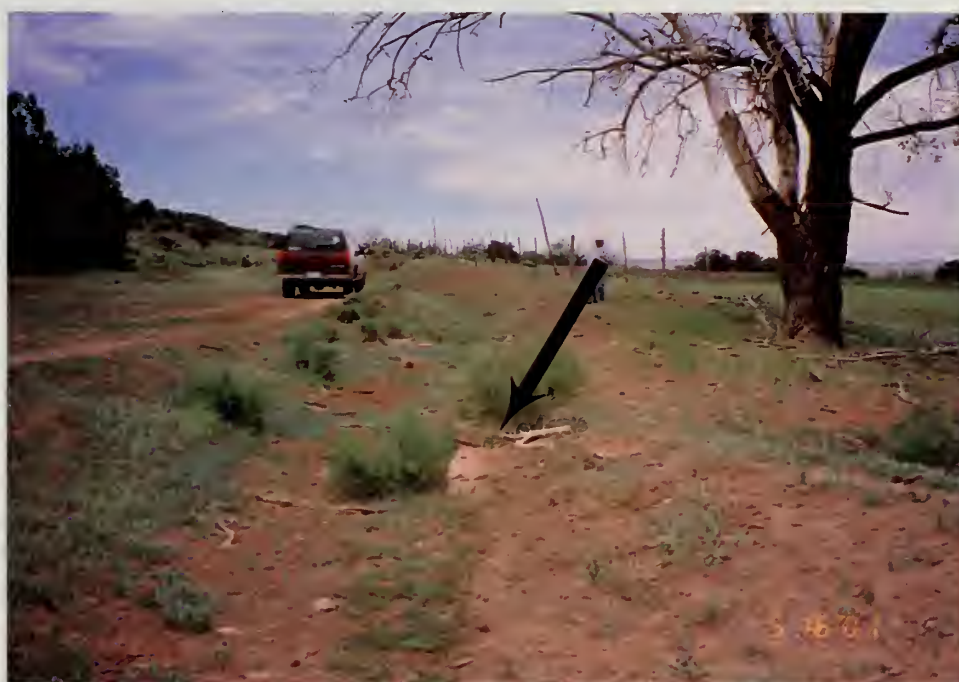
Water was supplied to the reservoir from the ditch between the road and the upstream embankment (photos 6 and 7) through inlets at the right (photos 6 and 8) and left (photos 9 and 10) ends of the upstream embankment. Releases were evidently made through the outlet works located at the right downstream corner of the reservoir shown in photographs 1 and 2. Outlet works discharges would flow onto the area downstream from the dam (photo 11) through the terminal structure, the remnants of which consist of two small masonry training walls shown in photograph 3. The low-level outlet is currently inoperable [OP]. There is no well-defined outlet channel downstream from the dam.

Photo 6. Hubbell Reservoir - Southern embankment segment and supply ditch, looking to the left (west). The arrow indicates the right upstream reservoir inlet headwall. Note the large tree growing on the embankment.

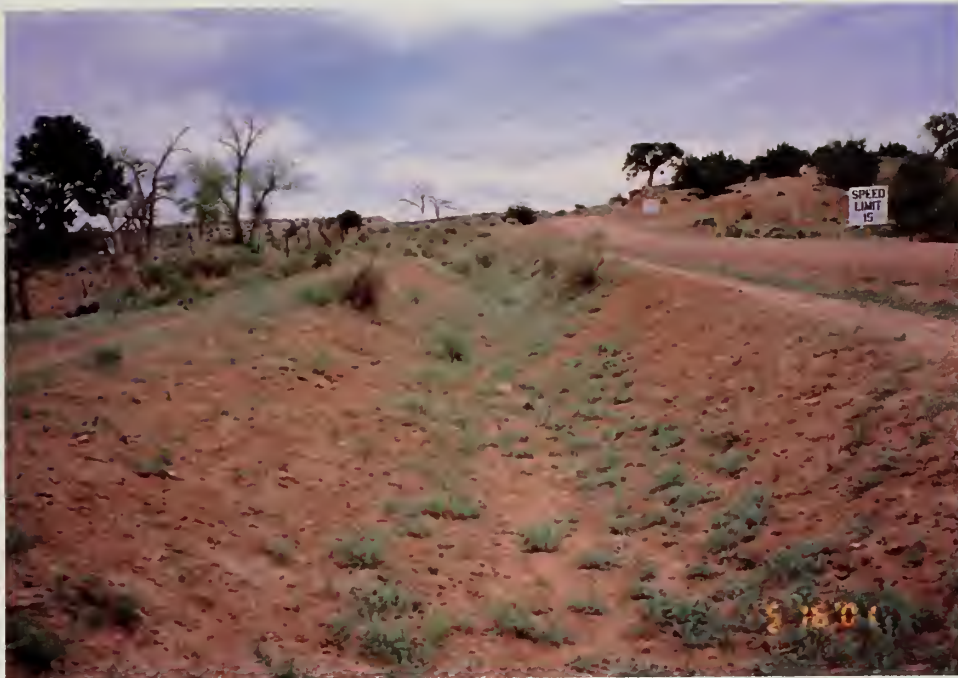
Photo 7. Hubbell Reservoir - Supply ditch looking right (east) along the southern embankment segment. 5/16/01

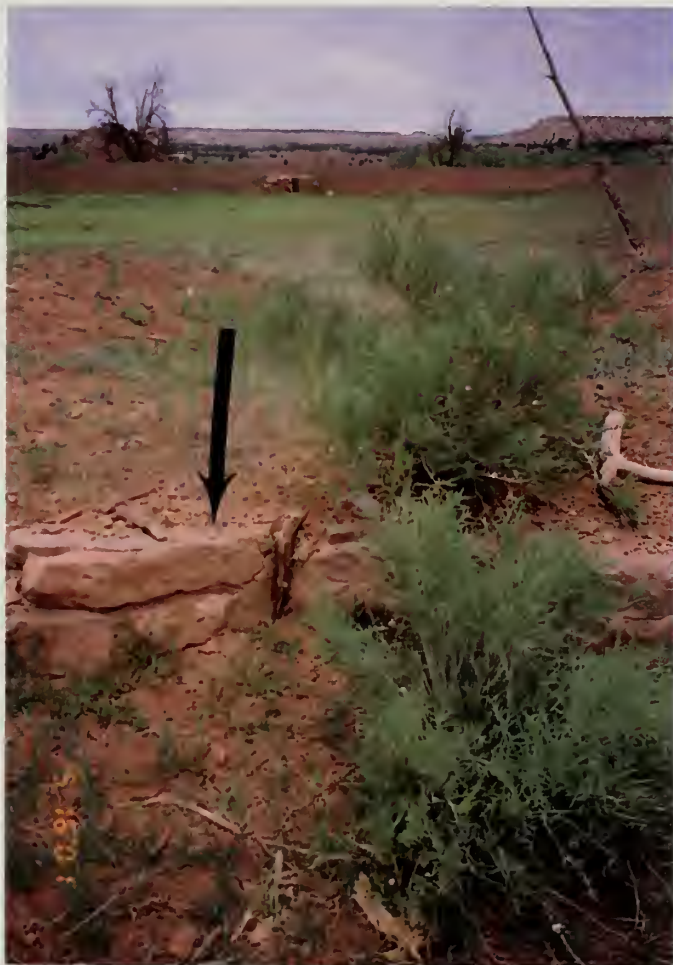
Photo 8. Hubbell Reservoir - The arrow indicates the right upstream inlet to the reservoir also shown in photograph 6. 5/16/01

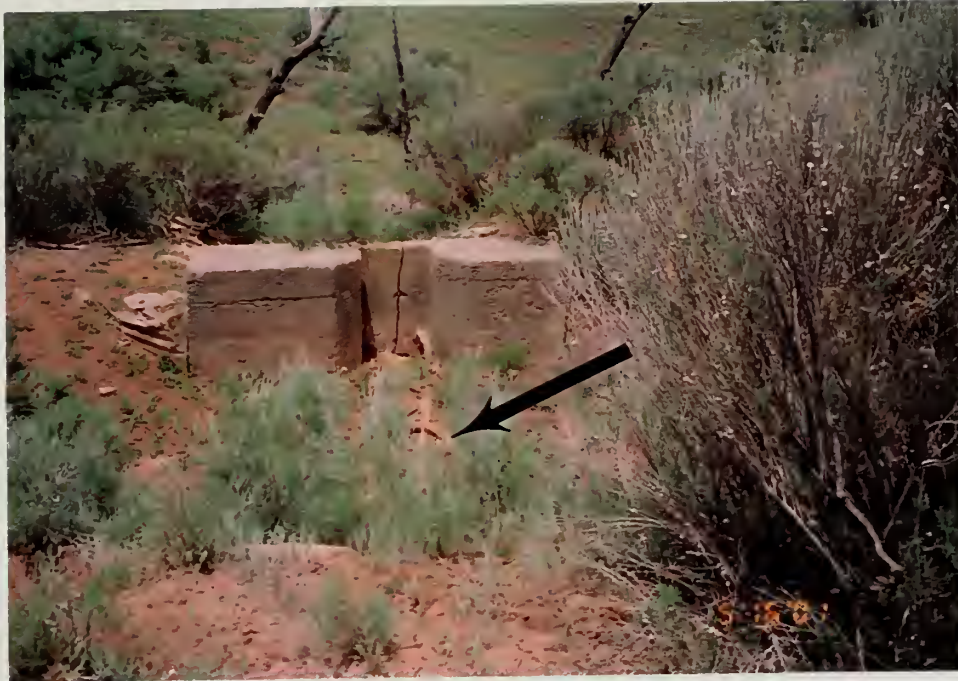
Photo 9. Hubbell Reservoir - Left reservoir inlet near the southwest corner of the reservoir, looking toward the reservoir. The arrow indicates the partially plugged inlet pipe. 5/16/01

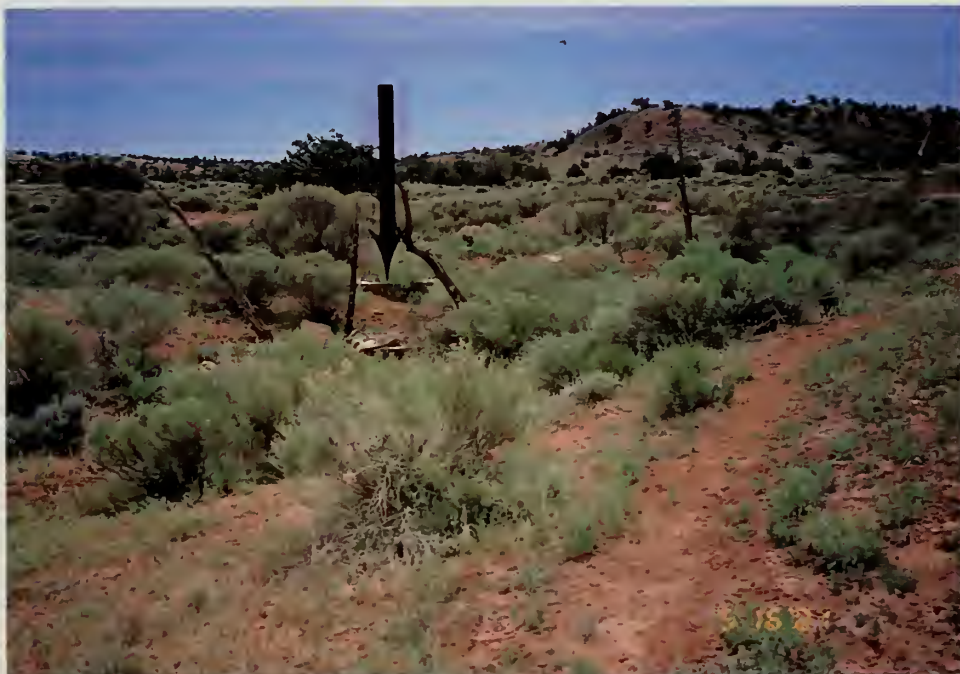
Photo 10. Hubbell Reservoir - The arrow indicates the inlet to the reservoir at the southwest corner of the reservoir shown in photograph 9, looking from the west embankment segment toward the road. 5/16/01

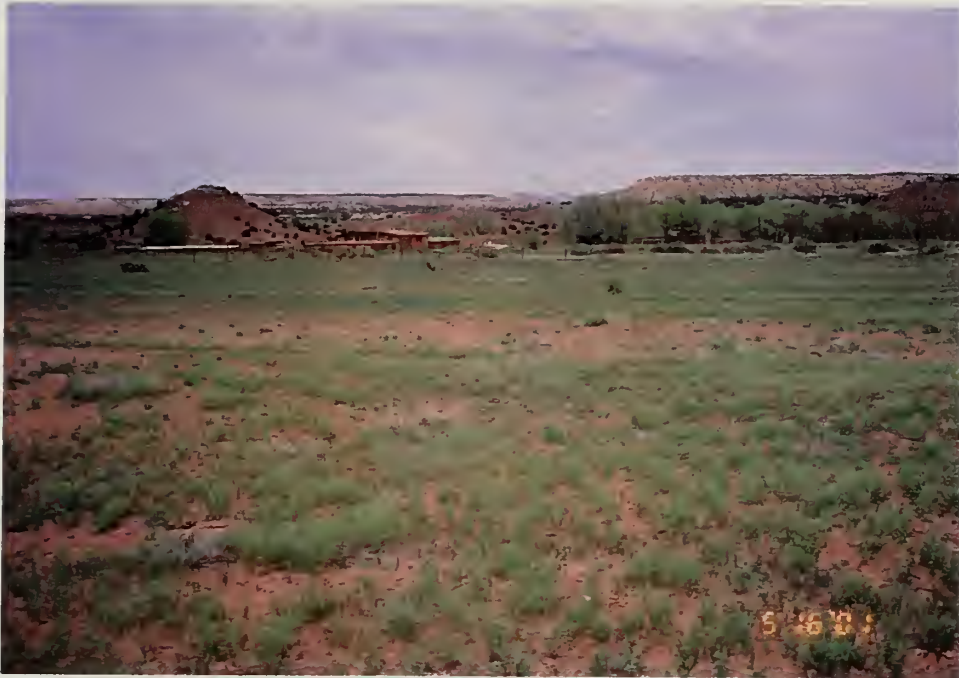
Photo 11. Hubbell Reservoir - Flat terrain downstream from the main (south) dam embankment segment. The structures in the background are part of the Hubbell Trading Post National Historic Site. 5/16/01

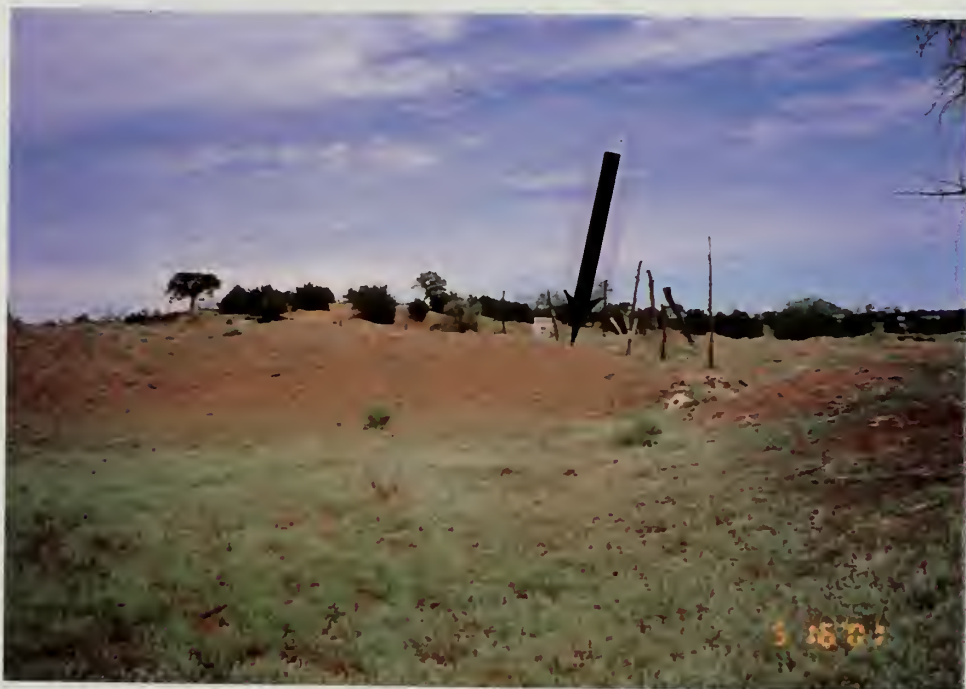
There is no spillway at this dam, and construction of a spillway is not necessary because this is an offstream facility. However, the right embankment slopes down to the elevation of the roadway upstream from the reservoir (photo 12); this would cause water to discharge into the wash on the right side of the reservoir (photo 13) in the unlikely event of high reservoir levels.

Photo 12. Hubbell Reservoir - Right (east) embankment segment, looking to the east near the road. The arrow indicates where the embankment segment tapers toward the road. This low area would act as a spillway in the unlikely event of high reservoir surface elevations. 5/16/01

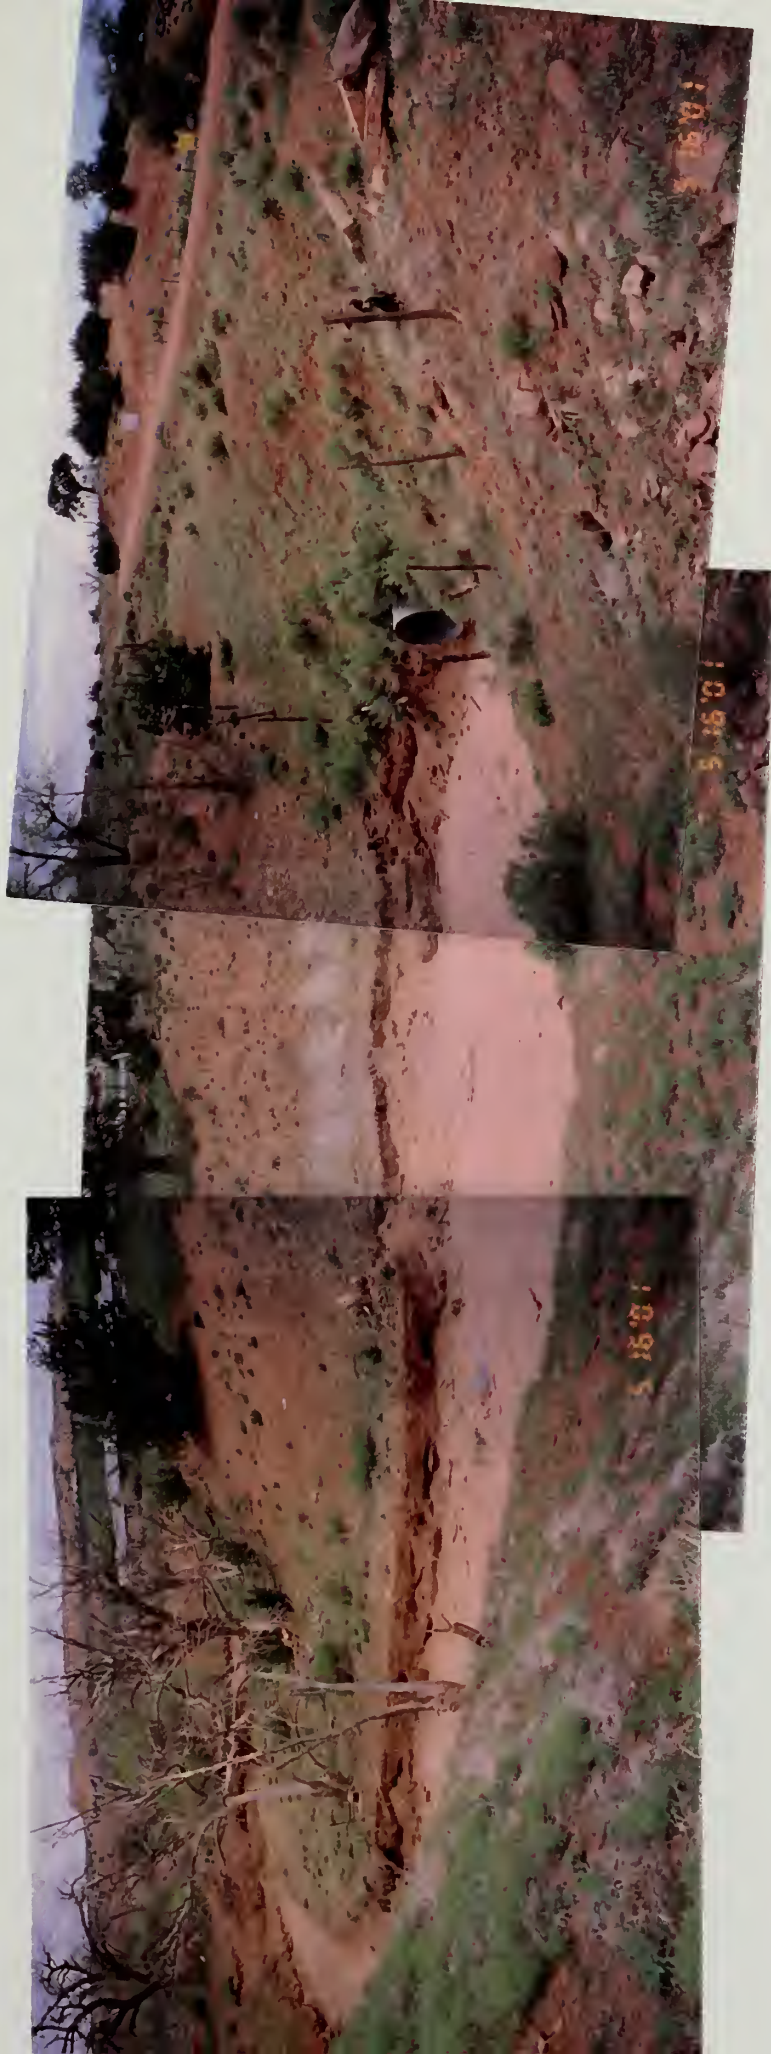
Photo 13. Hubbell Reservoir - Wash on the east side of the reservoir into which water would flow from the low area in the east embankment segment shown in photograph 12. 5/16/01
